CALIFORNIA DIVISION OF MINES AND GEOLOGY

FAULT EVALUATION REPORT FER-115

April 10, 1981

Calaveras fault zone, Mission fault, <sup>and</sup> San Felipe fault (figure 1).

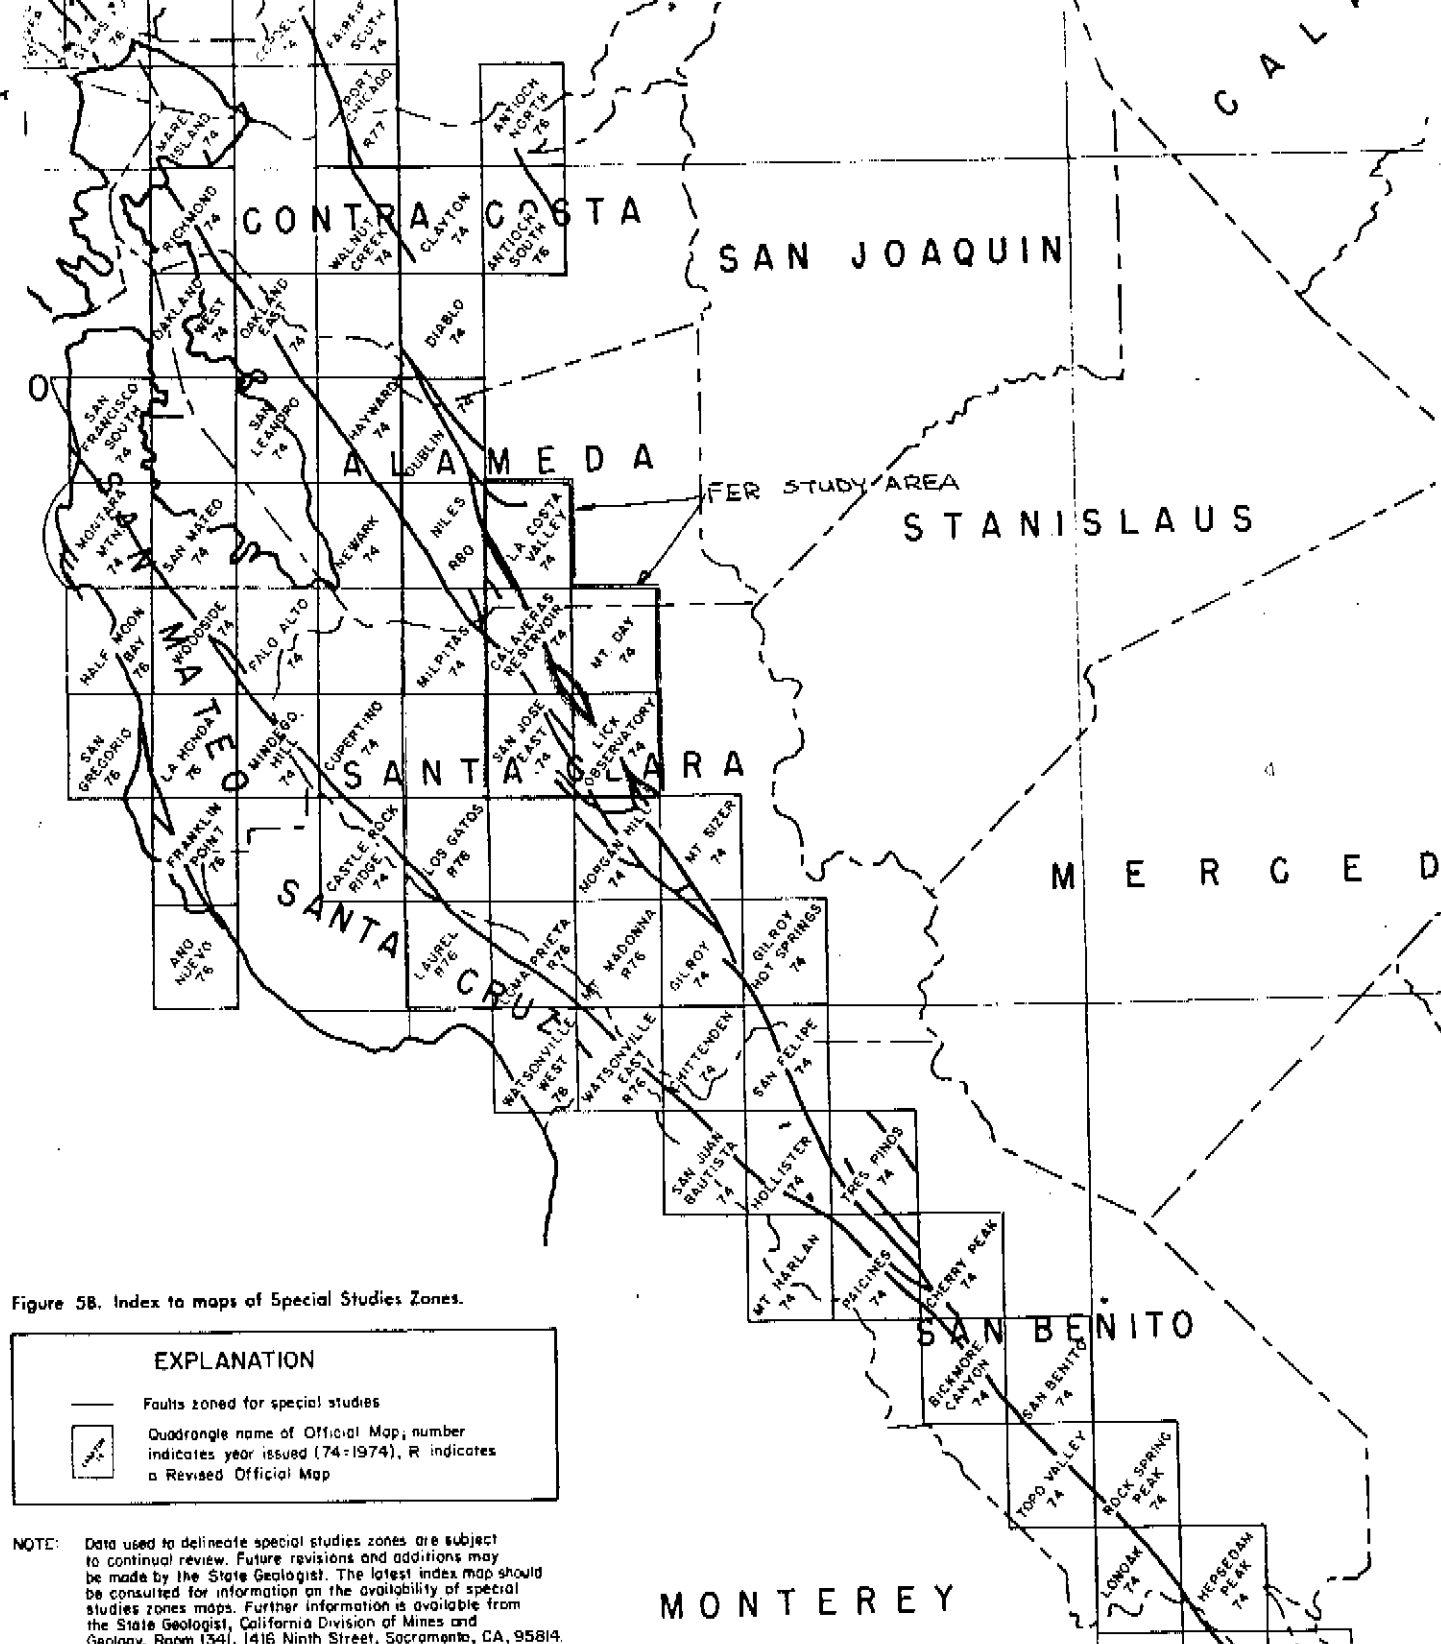
Figure 1 ( to FER-115 ). Location of Calaveras Area Fault zone (shown in green) to be evaluated in this FER. Map from Hart (1980, p. 13).
